GOVERNOR'S COMMITTEE

COAL MINE DISASTER

BEAR CREEK, MONTANA

The undersigned, comprising the Committee appointed by you to investigate the mine disaster at the Smith Mine of the Montana Coal & Iron Company, at Washoe, in Carbon County, Montana, respectfully submit the following report:

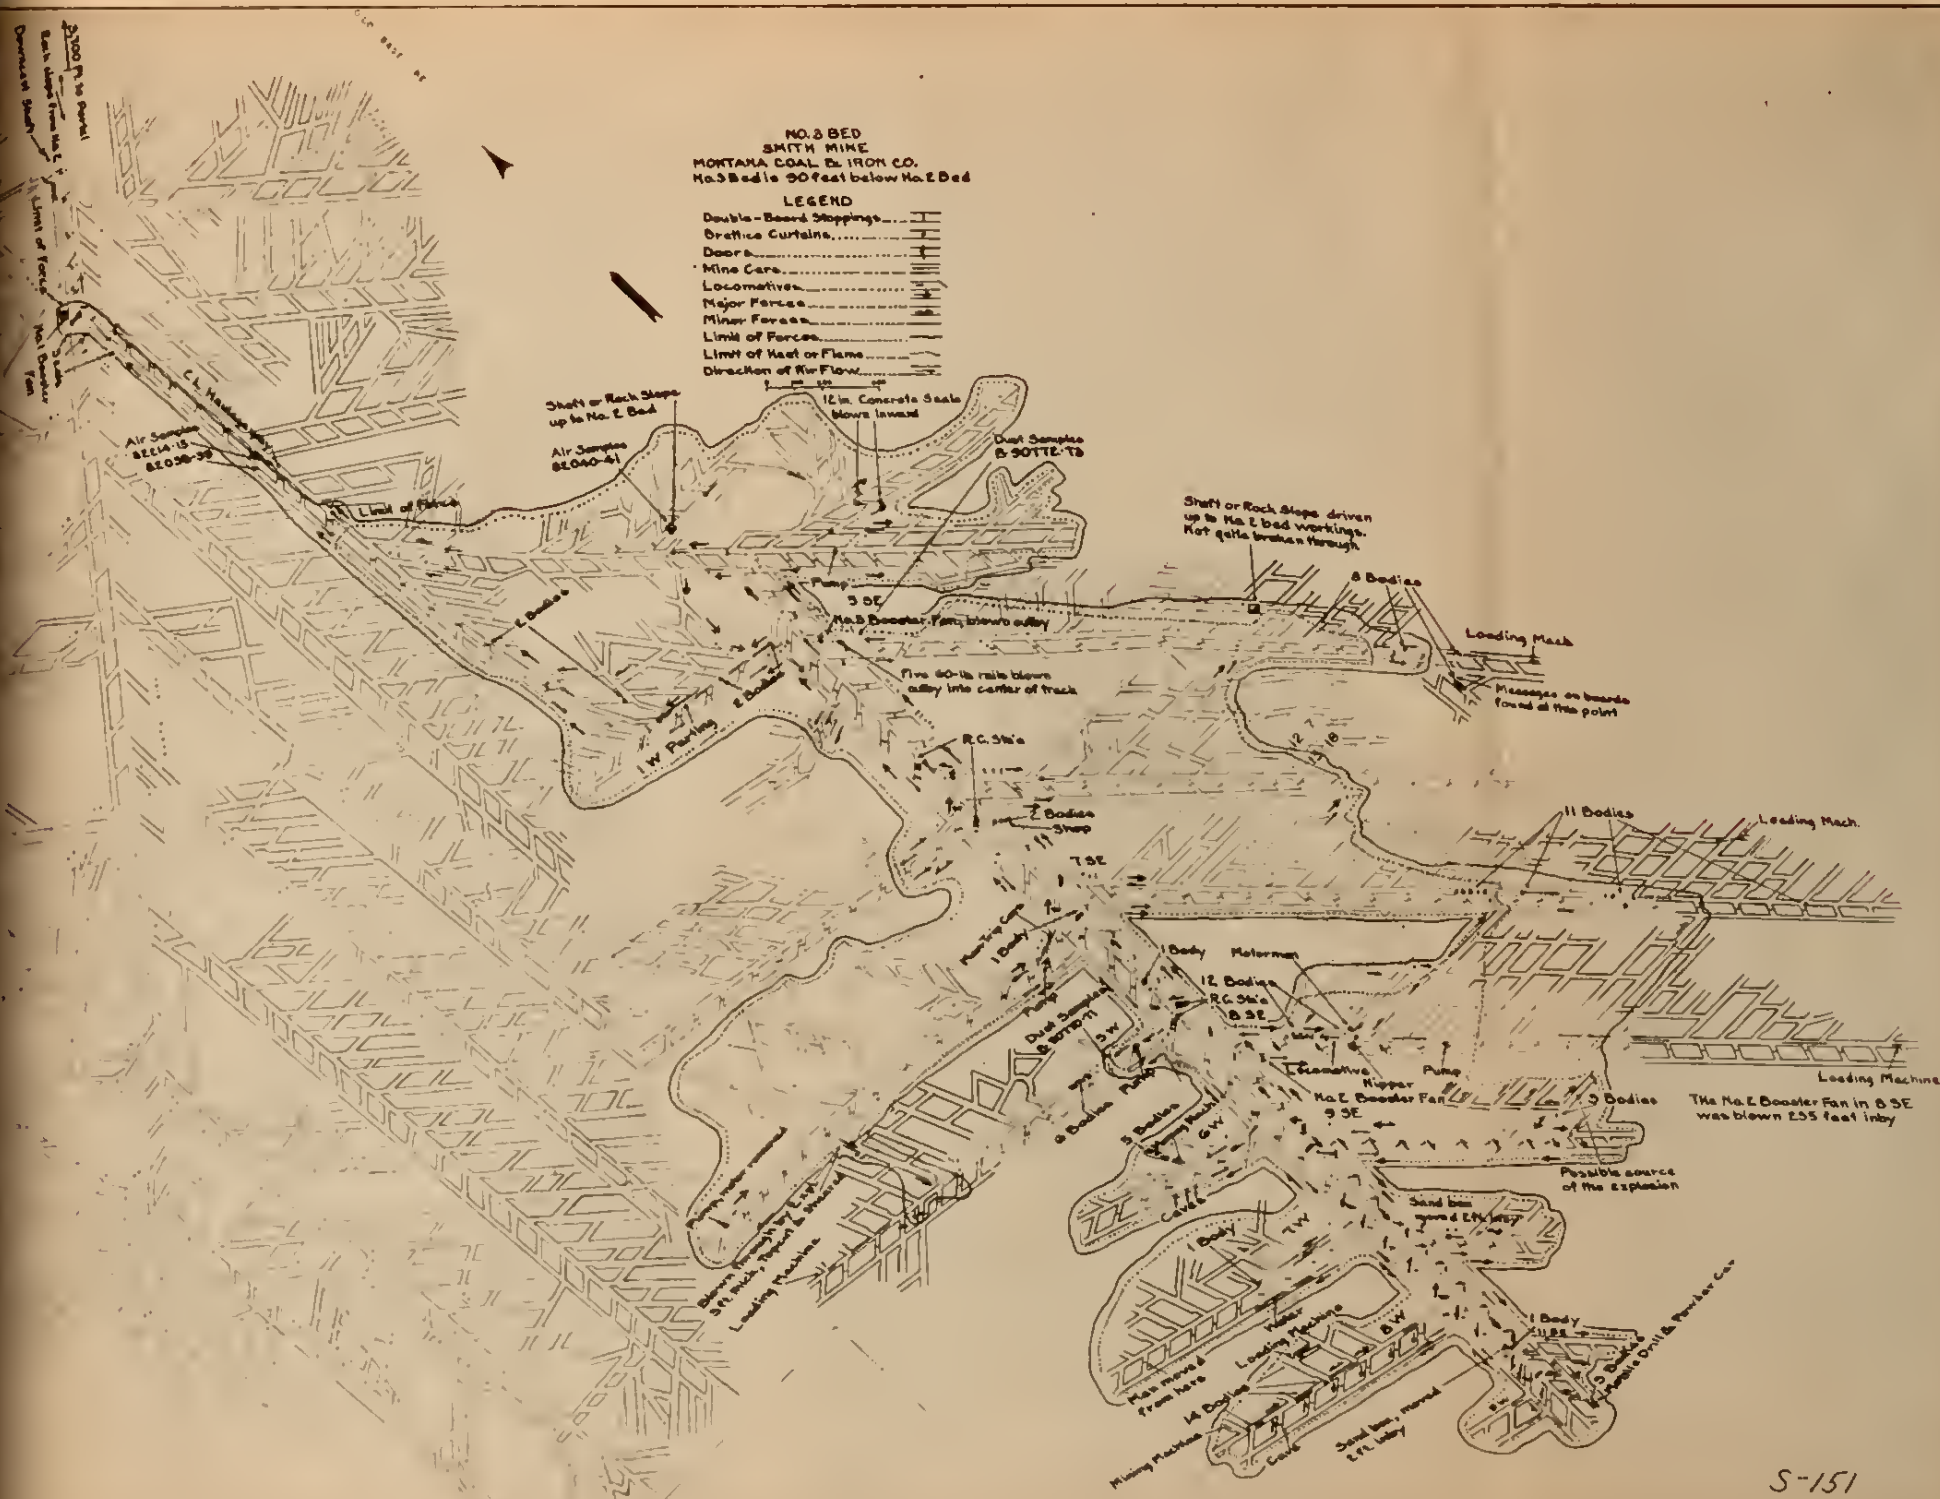
Forces of explosion traveled East to West and West to East. Stoppings between the main and back entries, indicated that forces traveled North to South. Evidence of intense heat in rooms. At the face of the main entry there was a trace of gas. Canvas opposite last cross cut burned to ash. Pump at 2nd cross cut from the face but no motor attached. The door in the slant between the Main South East middle and right back entries was blown West to East.

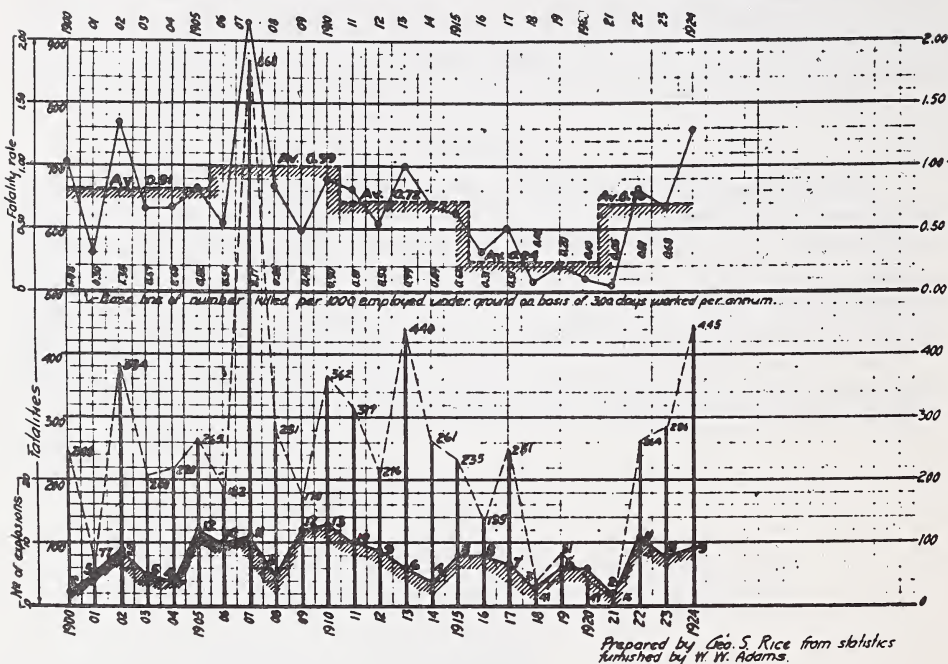
Annual Number of Explosions of Gas and Coal dust in Bituminous Mines of the United States 1900 to 1924 inclusive, in which 5 or more lives were lost, and total fatalities therefrom each year, also fatality rates per 1000 men employed under ground. Rates figured on basis: 300 days worked per annum.

From this tabulation we notice a decided improvement from 1913 to 1921, inclusive, during which period many thousands of electric safety cap lamps were installed. This very material reduction in mine explosion fatalities is a great tribute to this type of safety equipment.
